## Clinical Case Study ELIZ & OSIQ

**Case:** The patient's previous anterior cruciate ligament (ACL) reconstruction had failed and they therefore required revision ACL reconstruction which would be undertaken in two stages. Stage 1 was to remove the old screws and ACL remnant and fill the remaining holes in the bone with synthetic bone graft substitutes (KYERON BV).

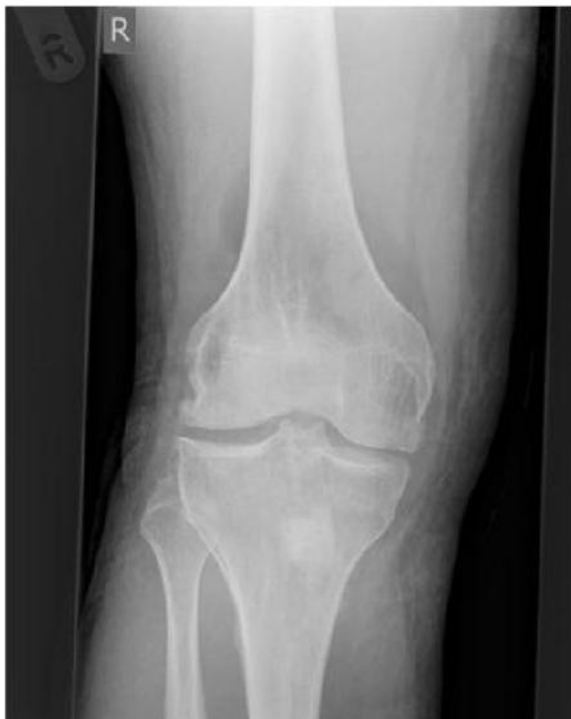
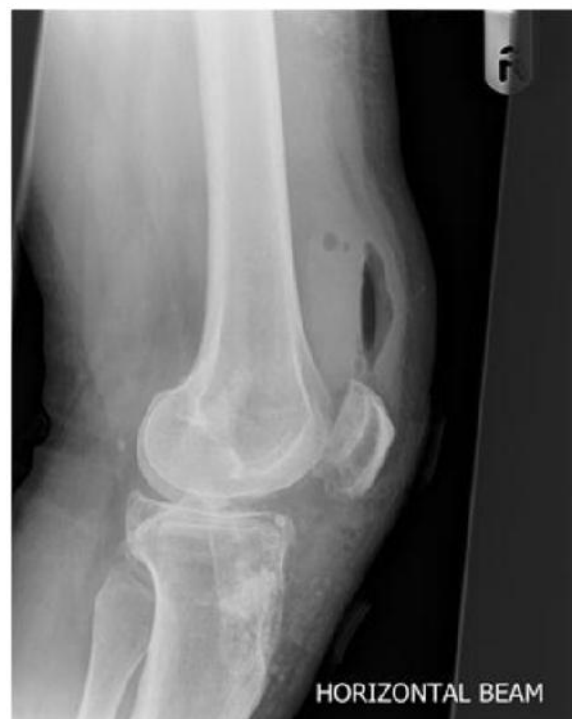
**Figure 1:** X-rays of the knee - anterior-posterior and lateral views one day after stage 1 of the surgical procedure (5.12.2012).

**Procedure:** The femoral screw was removed via small arthrotomy leaving bone cavity behind. This cavity was filled using 2.5cc OSIQ® paste. The tibial screw was removed which also left a bone cavity. This cavity was filled with 5cc of ELIZ® Granules (1-4mm). The wounds were then closed.

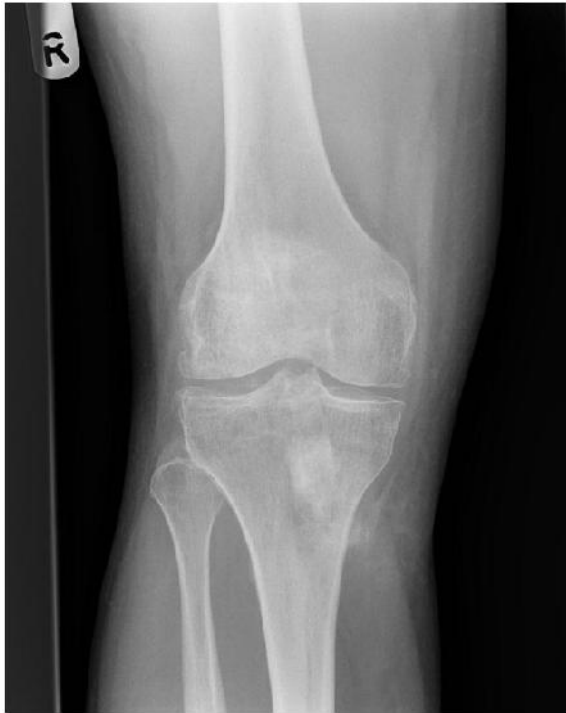
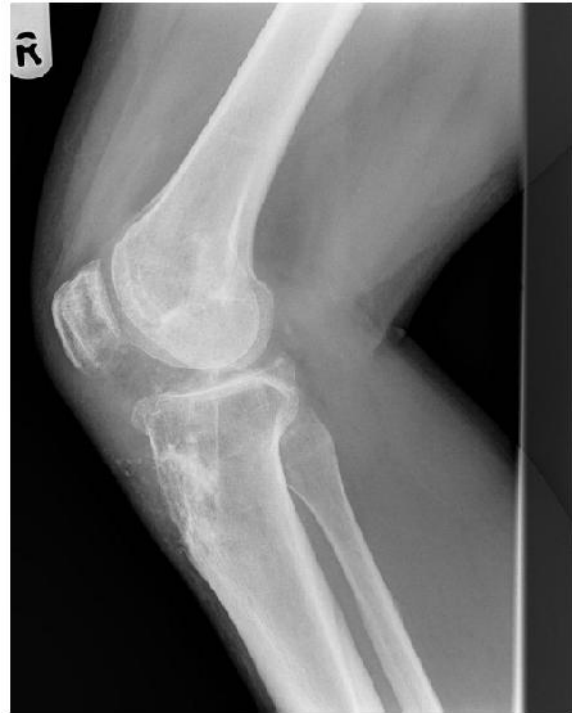
**Figure 2: X-rays of the knee - anterior-posterior and lateral views 6 weeks after stage 1 of the surgical procedure (21.01.2013).**

**Clinical Follow-up:** The patient was seen in clinic at 6 weeks and 3 months where x-rays were taken to observe the state of boney defects. The 2<sup>nd</sup> stage revision ACL reconstruction was performed on 19<sup>th</sup> March 2013.

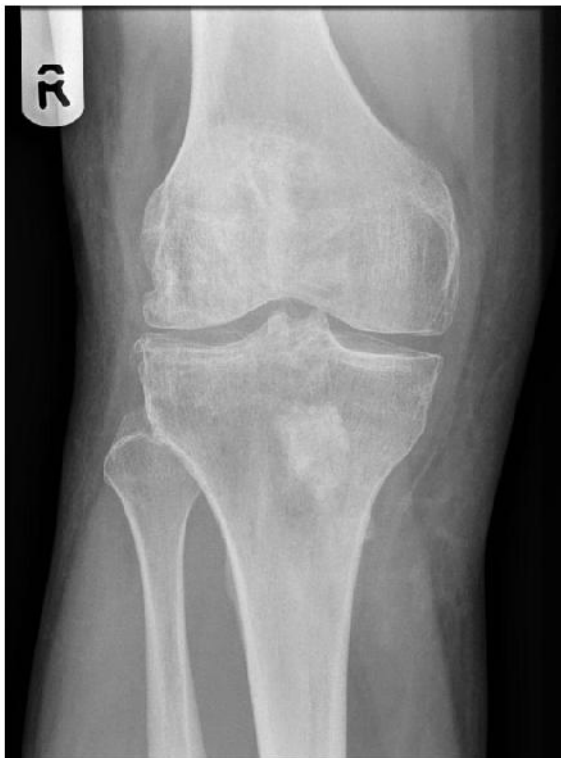
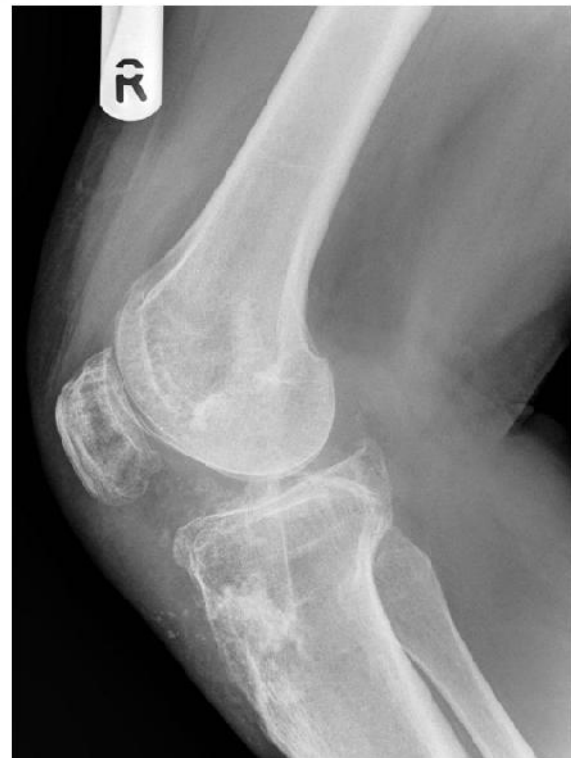
**Figure 3: X-rays of the knee - anterior-posterior and lateral views 3 months after stage 1 of the surgical procedure (04.03.2013).**

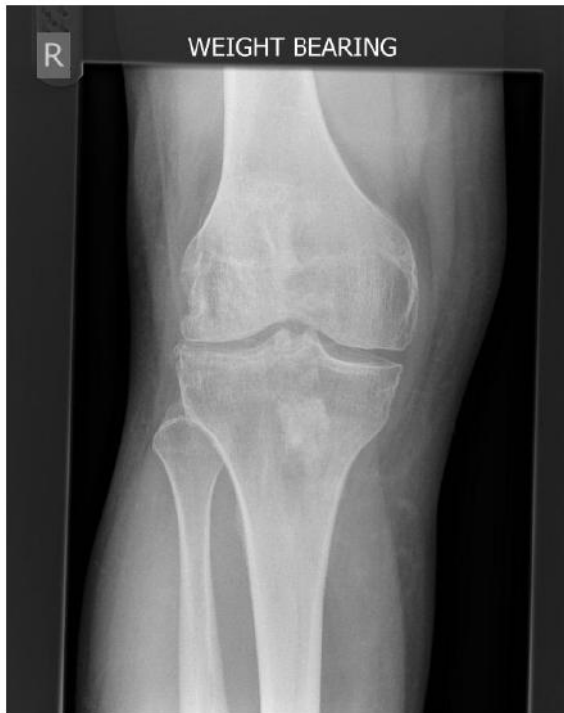
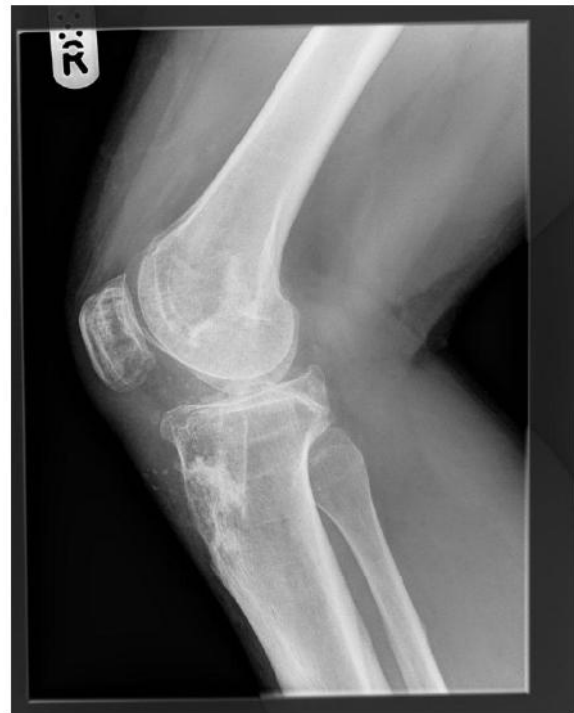
Figure 4: X-rays of the knee - anterior-posterior and lateral views 15 weeks after stage 1 of the surgical procedure (19.03.2013).

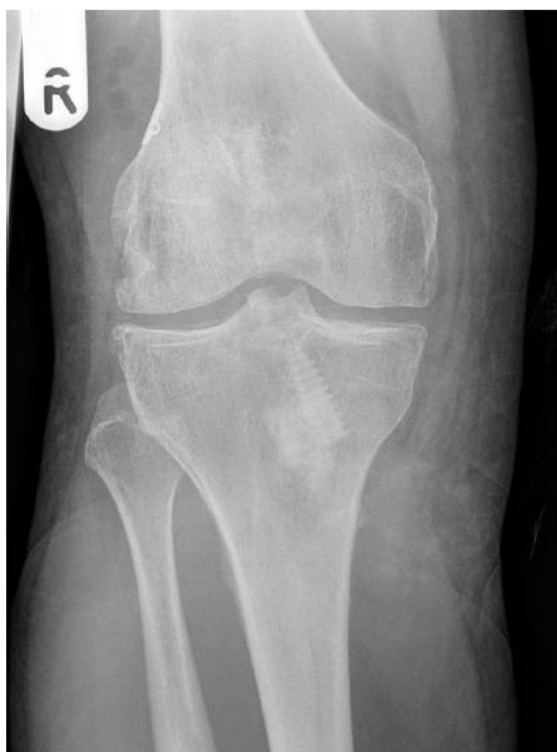
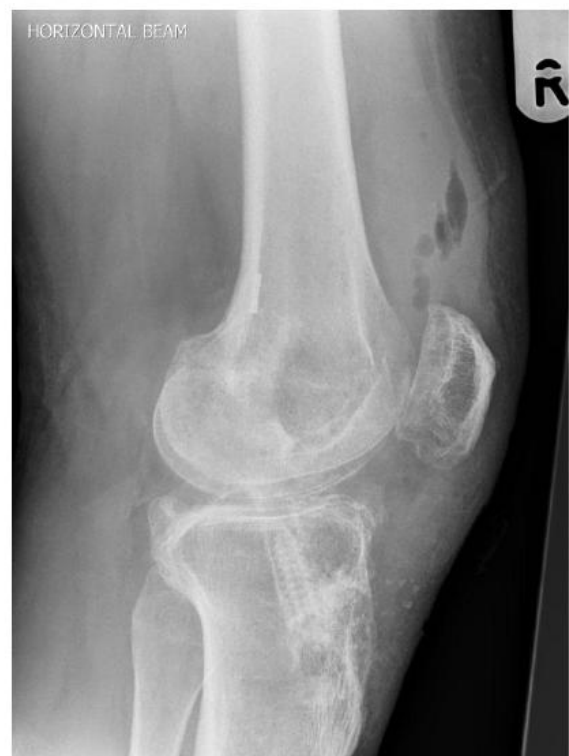
Figure 5: X-rays of the knee - anterior-posterior and lateral views day 1 post stage 2 of the surgical revision procedure (20.03.2013).

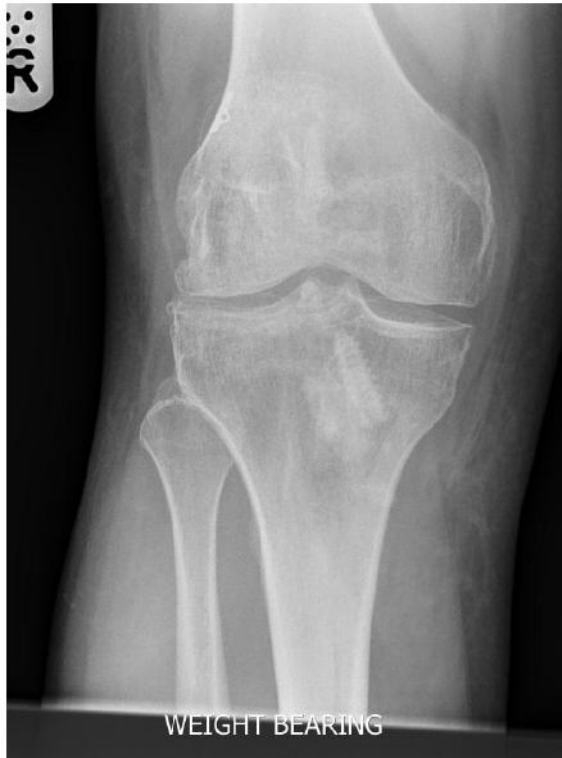
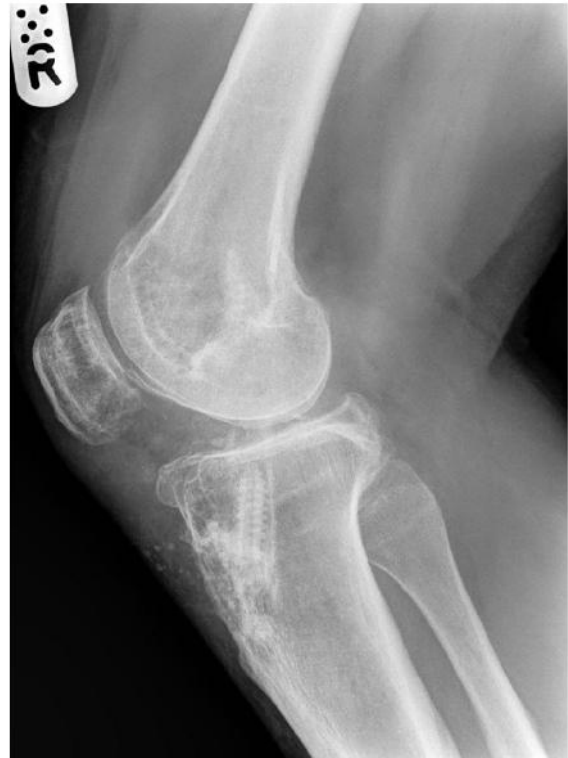
**Figure 6: X-rays of the knee - anterior-posterior and lateral views 1 month post stage 2 of the surgical revision procedure (29.04.2013).**
